February 8th, 2023

Development Authority of Berkeley County
Ms. Jennifer D. Smith
300 Foxcroft Avenue, Suite 201
Martinsburg, WV 25401

Limited Asbestos Inspection: 603 Packhorse Ford Road, Martinsburg, WV 25405

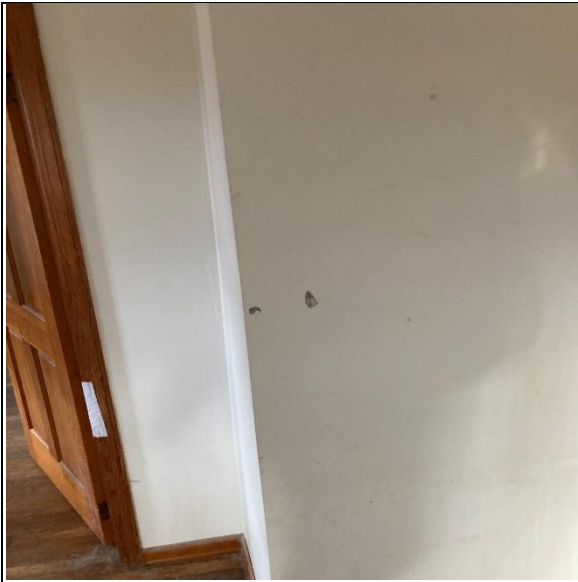
- ~8,000 square feet of drywall (joint compound included in estimate/cannot be separated) of walling and ceiling throughout tested positive (trace) at 0.75% pc.

Drywall/joint compound throughout
(TRACE)

During operations that may disturb materials containing < 1% asbestos, these materials must be handled by wet methods in order to minimize potential employee exposure to airborne asbestos fibers. This work practice must be followed by prompt cleanup and disposal of asbestos waste and debris using leak tight containers. Exposure monitoring of

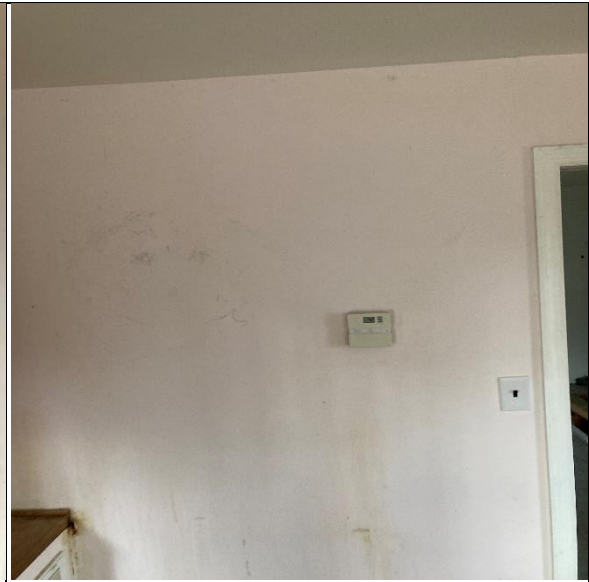
Drywall/joint compound throughout
(TRACE)

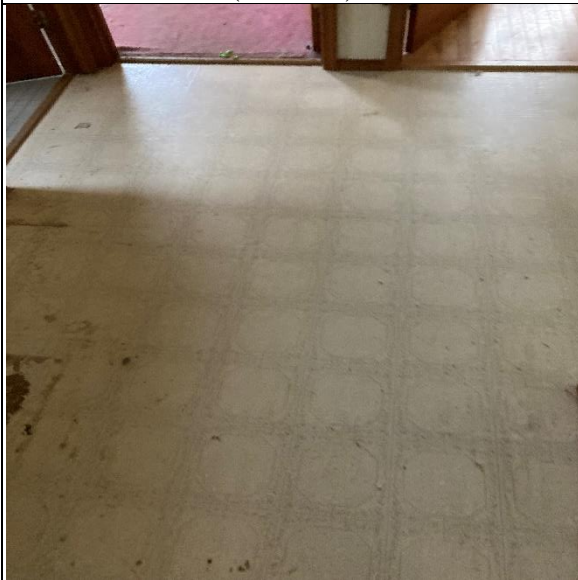
Off white sheet flooring in laundry area

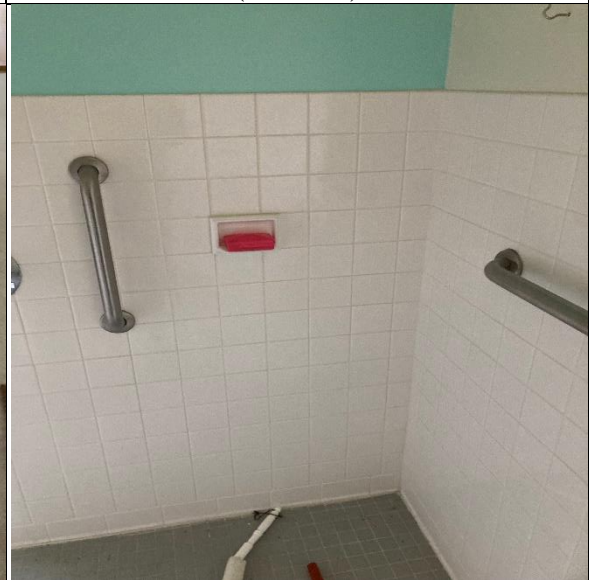
Ceramic tile walling in bathroom

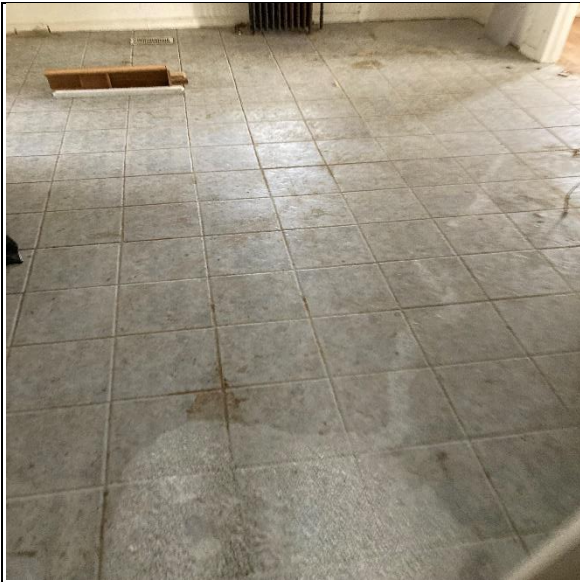
Ceramic tile and grout in kitchen

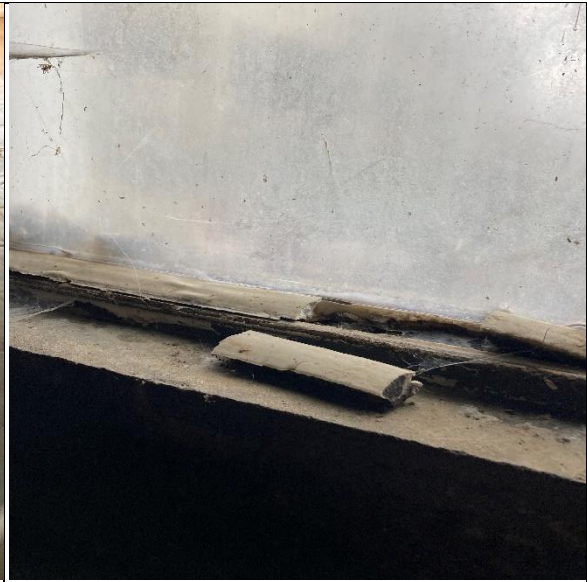
Metal frame window glazing in basement

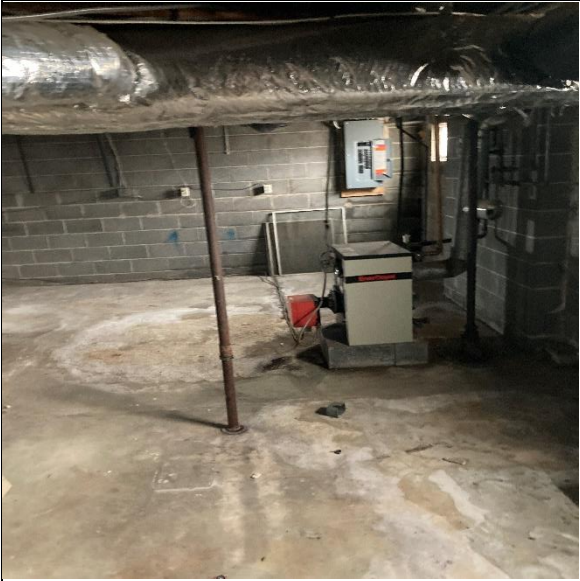
Basement flue mud

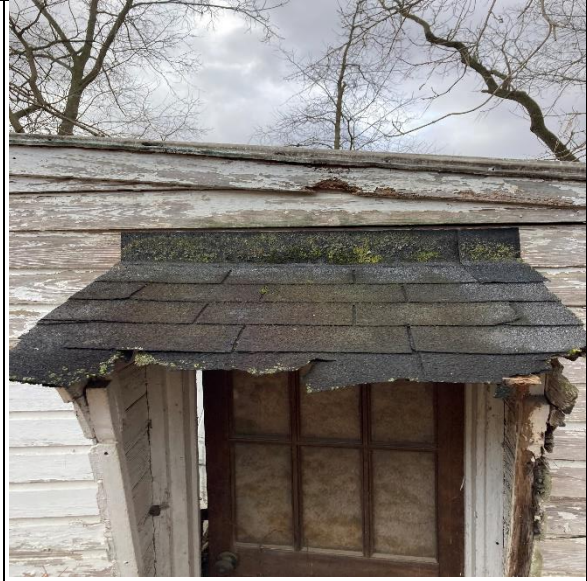
Black asphalt roofing at shed entry

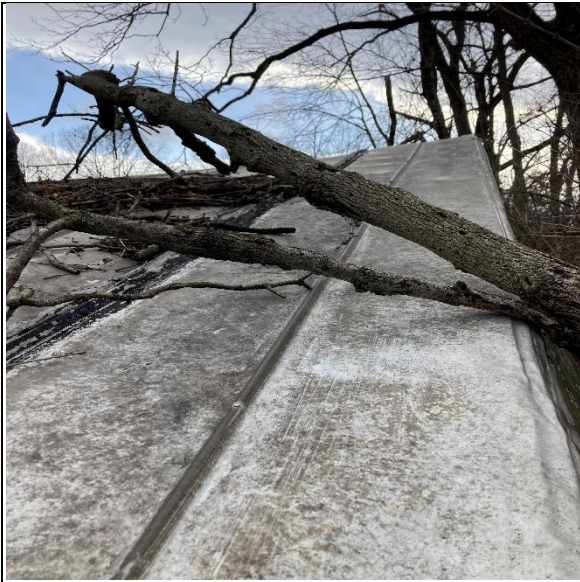
Silver roof coating on shed

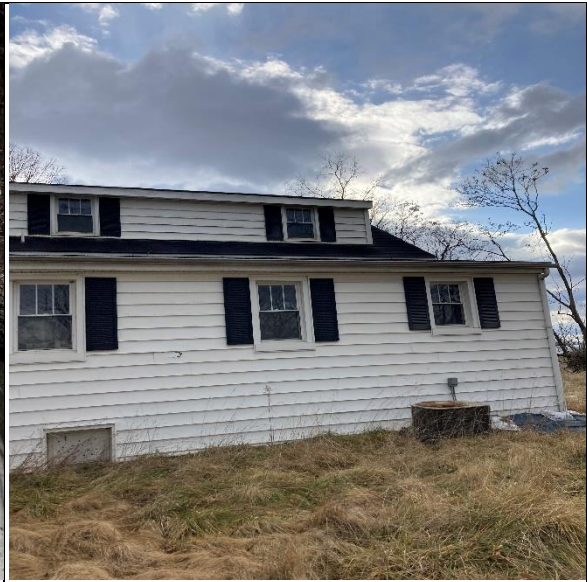
Black asphalt shingles and felt paper

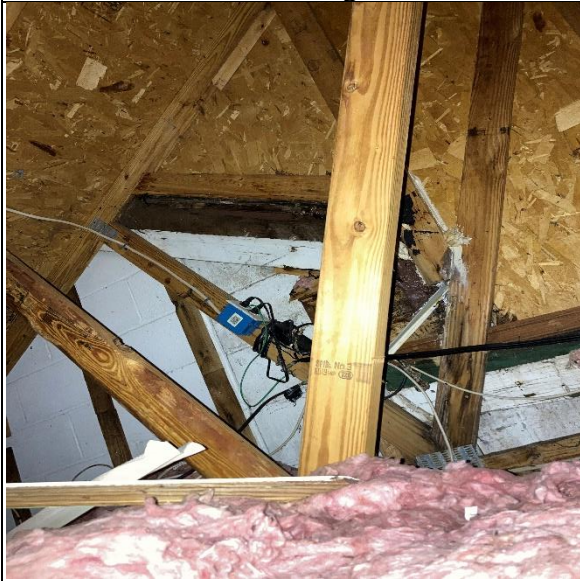
Attic area with fiberglass insulation
