February 8th, 2023

Development Authority of Berkeley County
Ms. Jennifer D. Smith
300 Foxcroft Avenue, Suite 201
Martinsburg, WV 25401

Limited Asbestos Inspection: County Route 9/30, Martinsburg, WV 25403

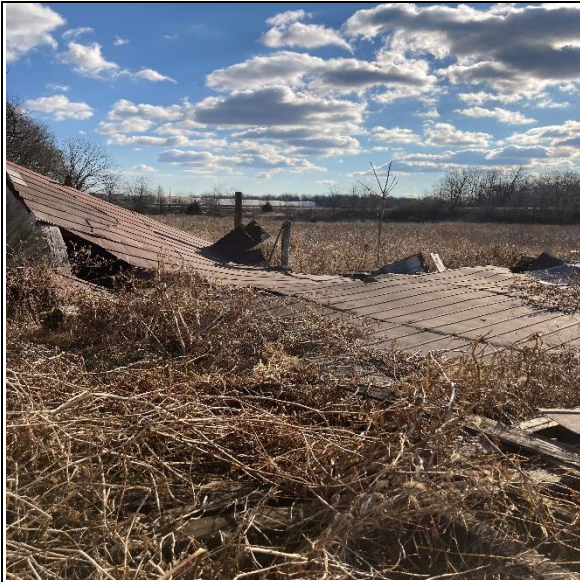
- *~5,000 square feet of black/gray metal seam tar on Building #1 as marked on map. It should be noted that the majority of the roofing material had collapsed to the ground at the time of the sampling event. 5,000 square feet is estimated total roofing material, the asbestos containing material is only located on seams that were visible and less than 5,000 square feet.*
- *~208 square feet of yellow design sheet flooring (3rd layer) in kitchen area.*

Building 1 – Asbestos containing seam tar

Positive asbestos material is defined by the CVES method when there is 1% or greater volume of asbestos, by weight, in the sample. Prior to any renovation or demolition occurring at the site, which would disturb any positively identified material, abatement should occur utilizing a licensed abatement contractor. Upon removal of the material, a manifest of disposal should be provided in the final report.

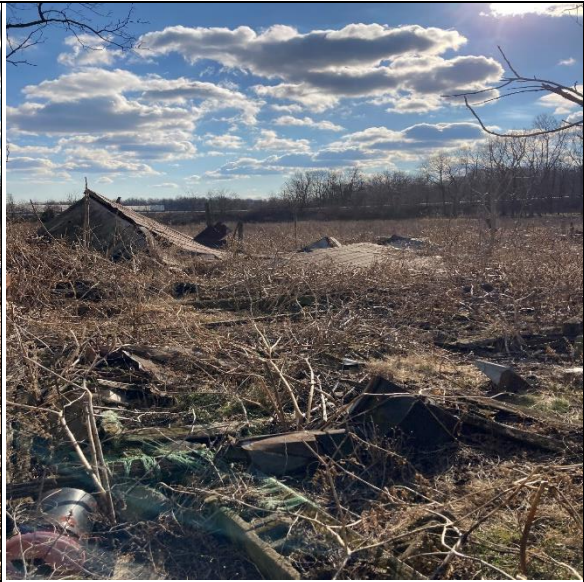
Building 1 – Asbestos containing seam tar

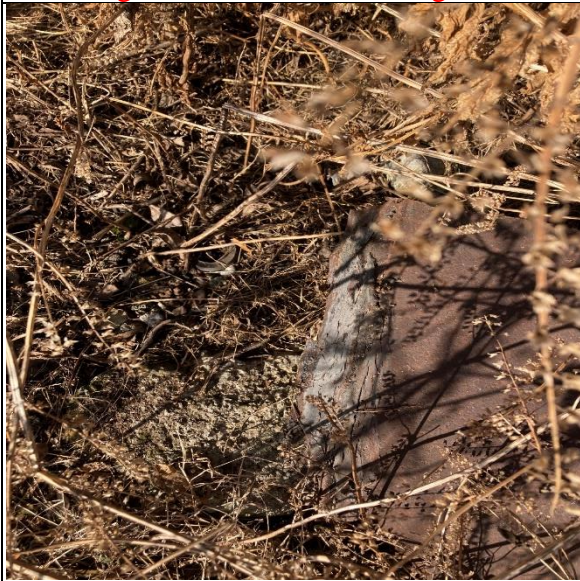
Building 1 – Asbestos containing seam tar

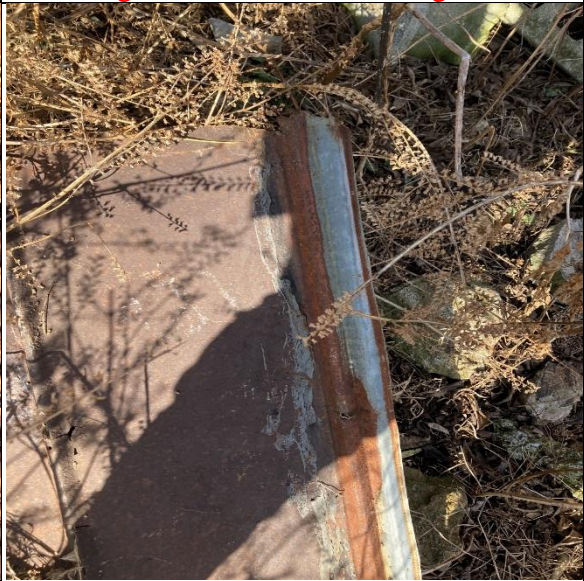
Building 1 – Asbestos containing seam tar

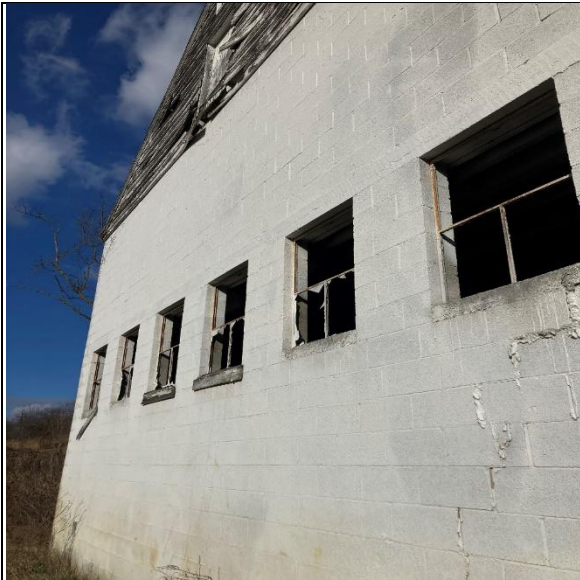
Building 2 – White window glazing

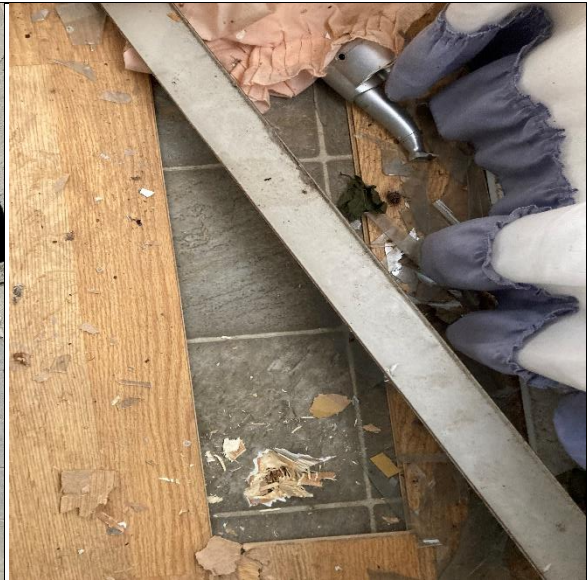
Gray sheet flooring in 2nd floor bathroom

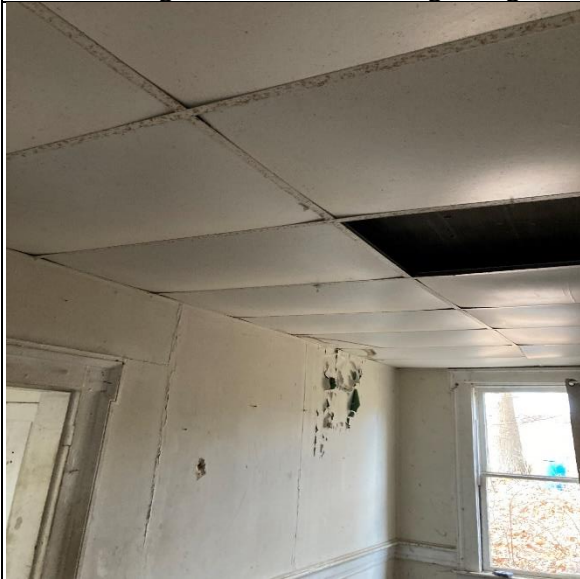
Smooth 2'x4' ceiling tiles throughout 2nd floor and 1st floor

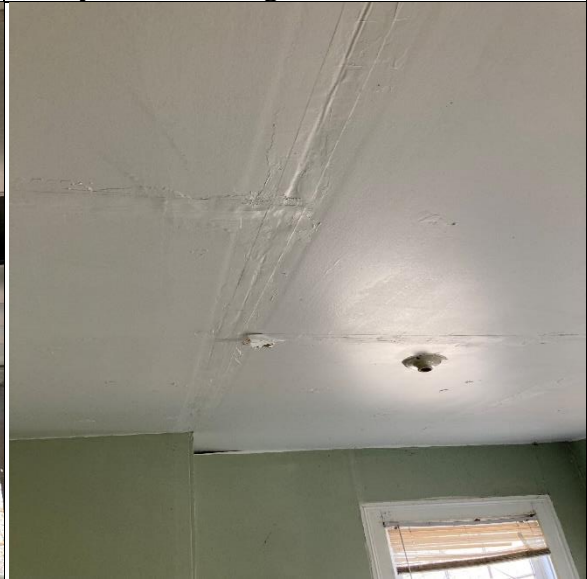
Drywall/joint compound on 2nd floor

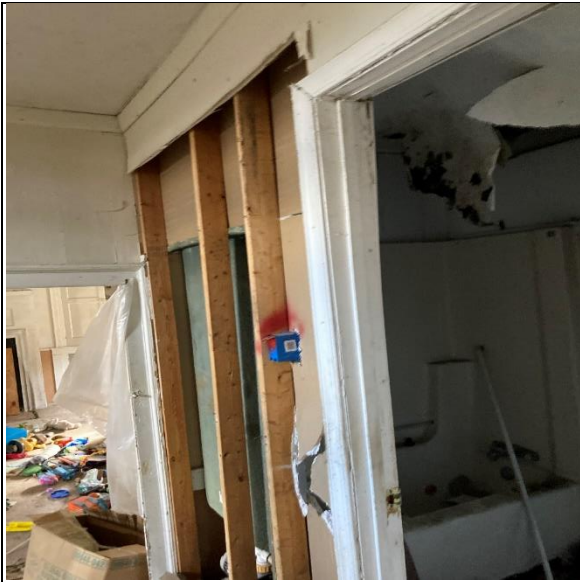
Drywall/joint compound on 1st floor

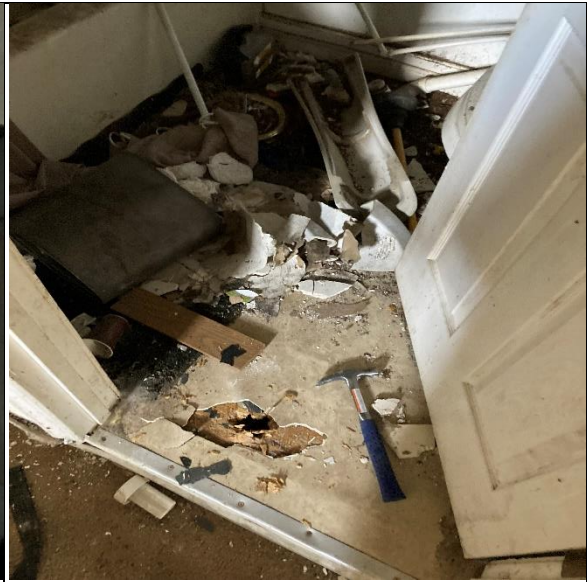
Off white sheet flooring in 1st floor
bathroom

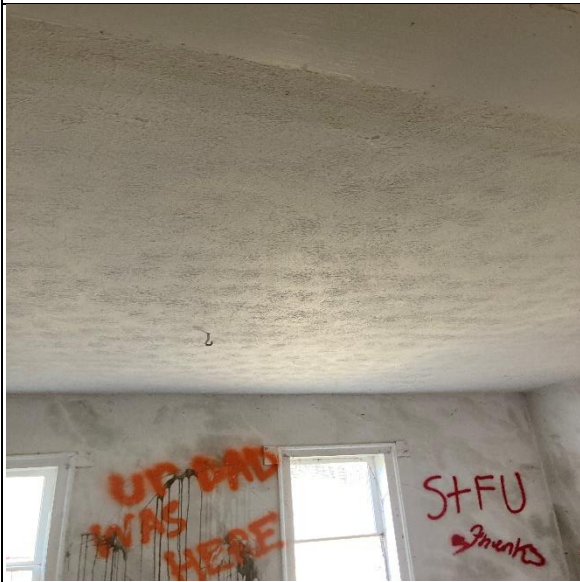
Textured ceiling material in living room
area

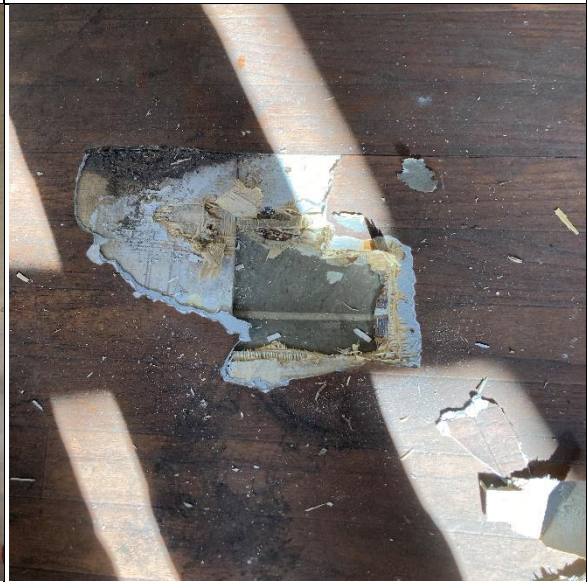
Faux wood and gray sheet flooring in
kitchen

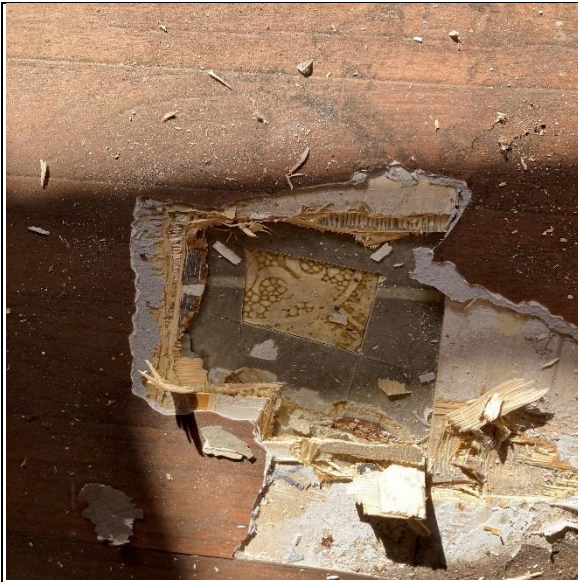
Asbestos containing yellow design sheet
flooring base layer in kitchen

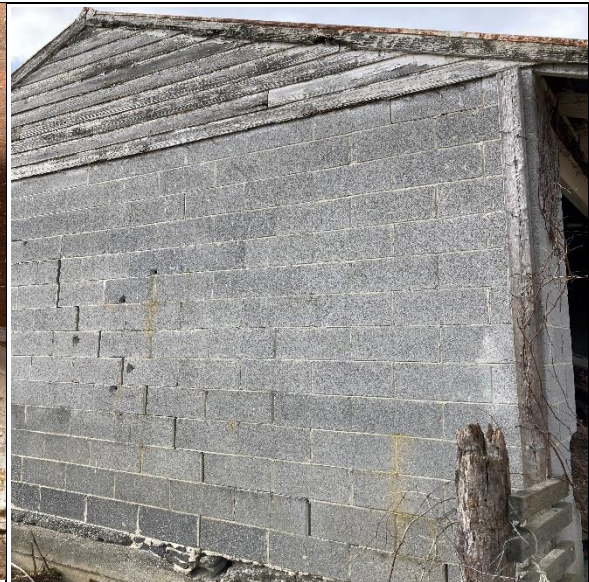
Building 3 - CMU block and mortar
